Gleensk Viaduct Principal Inspection Report

**GLEENSK VIADUCT,
GLEENSK,
CO. KERRY.**

**PRINCIPAL INSPECTION, INVENTORY REPORT
AND WORKS PROPOSAL**

Project & Document No	Revision	Prepared By	Checked By	Approved By	Status	Date
15646/6002	A	B Sayers	J O'Leary	J O'Leary	For Info.	30.10.13

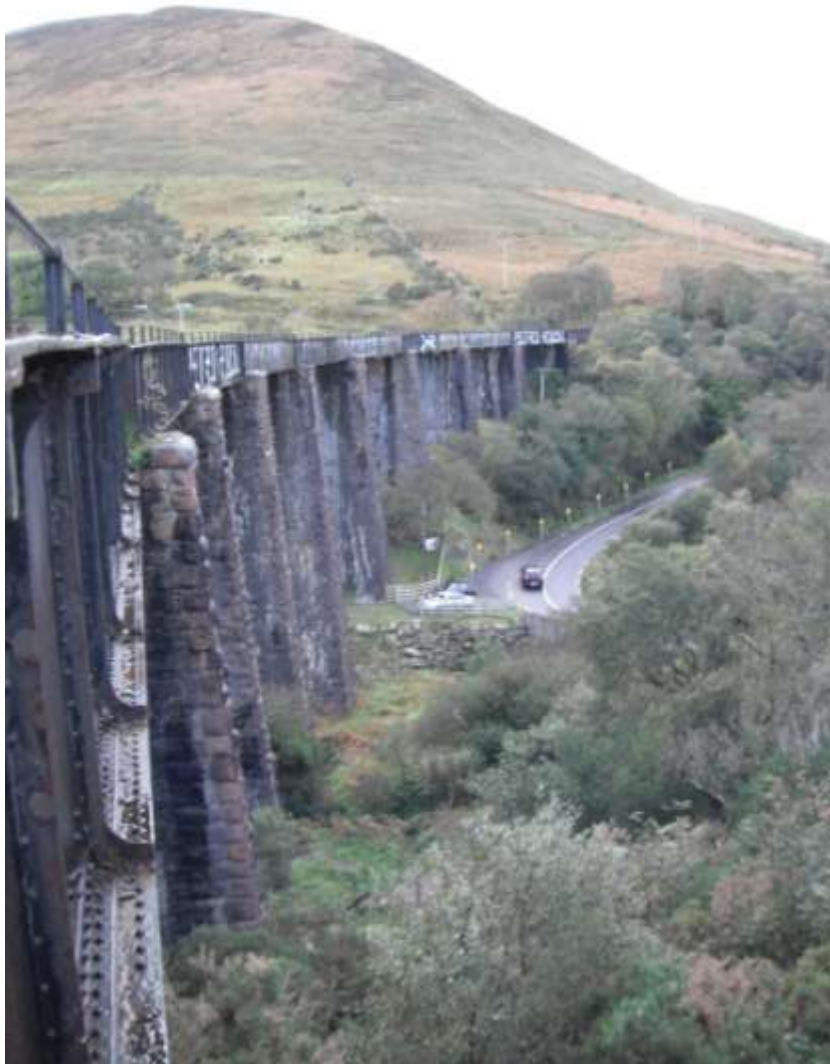
Figure 1 : General view along bridge from the east.

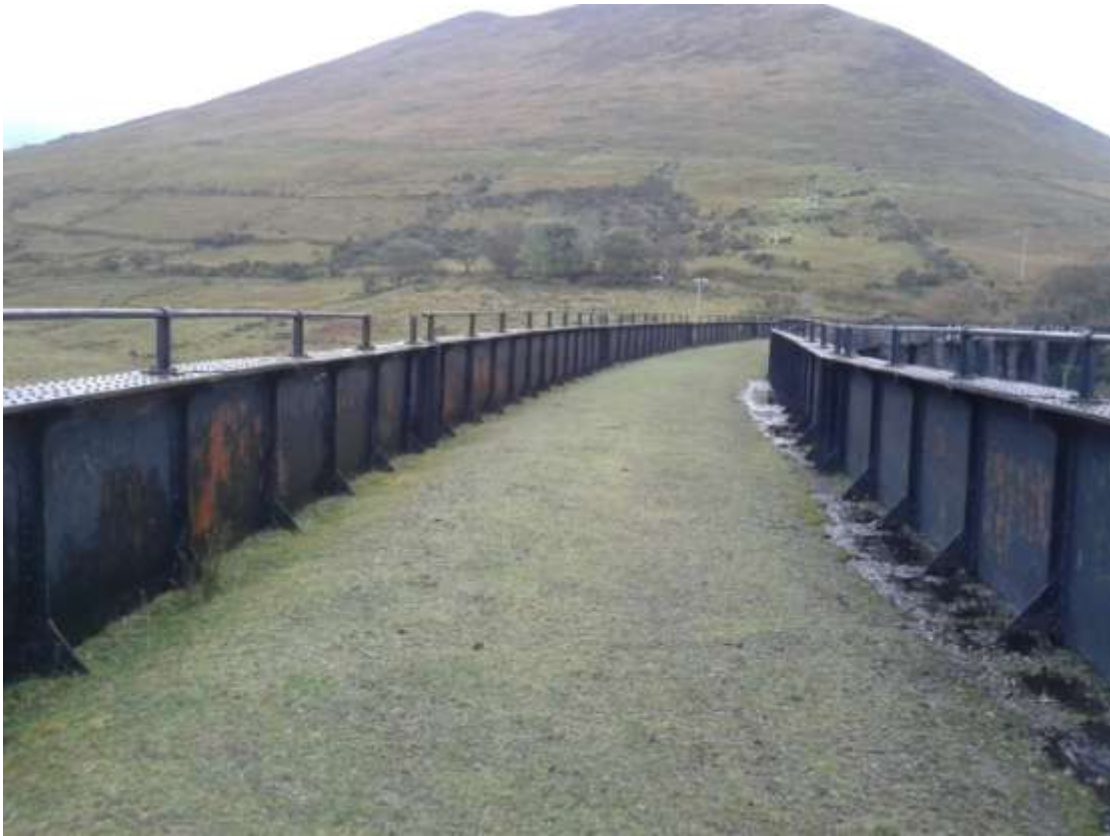
Figure 2 : General view along deck showing plate girders, build-up of stone/soil material and CHS handrailing.

6.0 Principal Inspection										
Client:		Kerry County Council				Road No:		Gleensk River		
Area:		Gleensk, Co. Kerry				Structure Name		Gleensk Viaduct		
Date of Inspection:		29/10/2013				Inspectors:		BS		
Weather:		Wet				Year of Next PI		2017		
Component No. & Name	Cond. Mark	Routine Maint.	Spec. Insp. Reqd.	Description of Damage	Photo No.	Type of Repair	Quantity of Repair	Year of Repair	Cost	
1	Bridge Surface	1	-	-	Surfacing to be removed as it is slippery in rain and not suitable for pedestrians or cyclists.	F2,F3	-	-	-	-
2	Expansion Joints	0	N	N	Expansion joints are working as was always intended. It was never expected that the joints would prevent water reaching the piers. Water on the piers does not appear to have caused any damage.	F7	-	-	-	-
3	Footway/ Median	-	-	-	-	-	-	-	-	-
4	Parapet/ Guardrail	3	Y	N	The CHS on top of the plate girders is missing in places and corroded in others. This needs to be replaced in some locations.	F2	Steelwork	See Section 7.	-	See Sec. 7

The remedial and upgrading works to allow safe pedestrian use of the bridge are very minor in nature. The existing soil/stone capping to the deck needs to be removed. Any serious corrosion of the deck should be repaired. A tar waterproofing exists on the deck at present and this should also be repaired with a hot-pour bitumen. A thin layer of gravel may be required to provide slip resistance. The existing CHS railing on top of the plate girders should be removed where significantly corroded and replaced with a galvanised and painted 50mm dia. CHS (25% replacement considered appropriate).

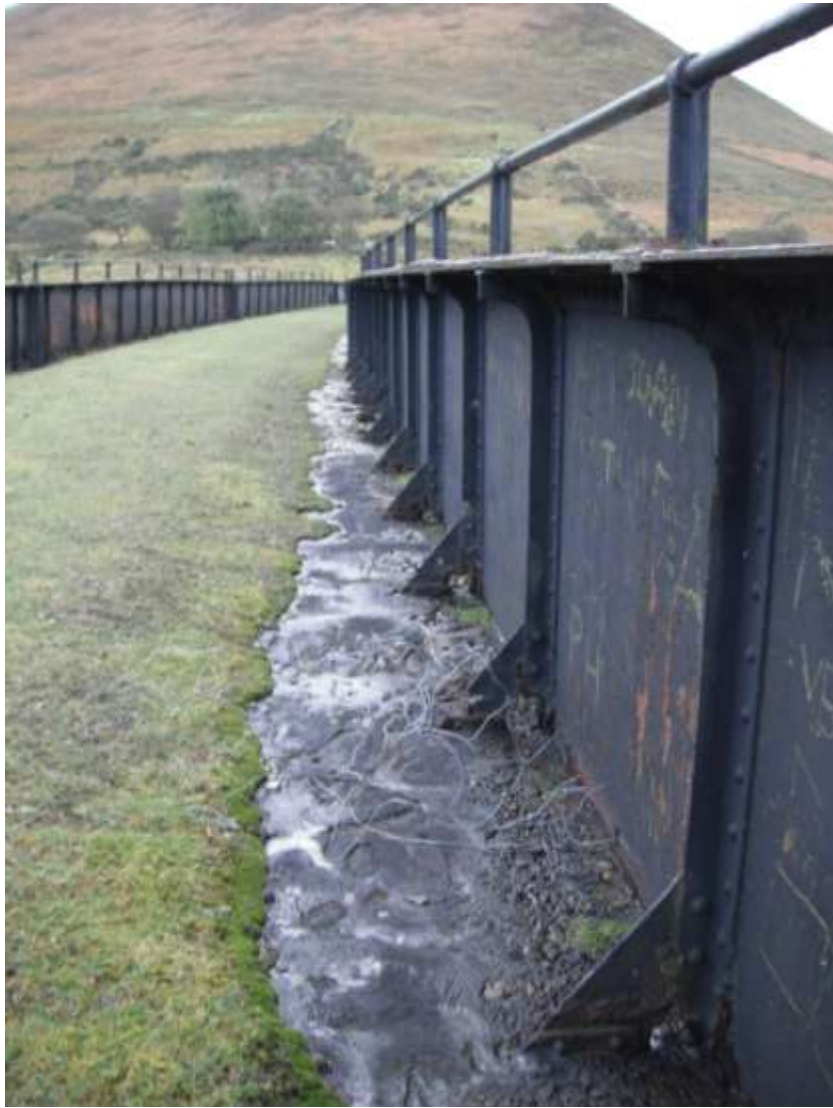
Figure 3 : Plate girder and tar waterproofing on structural deck.

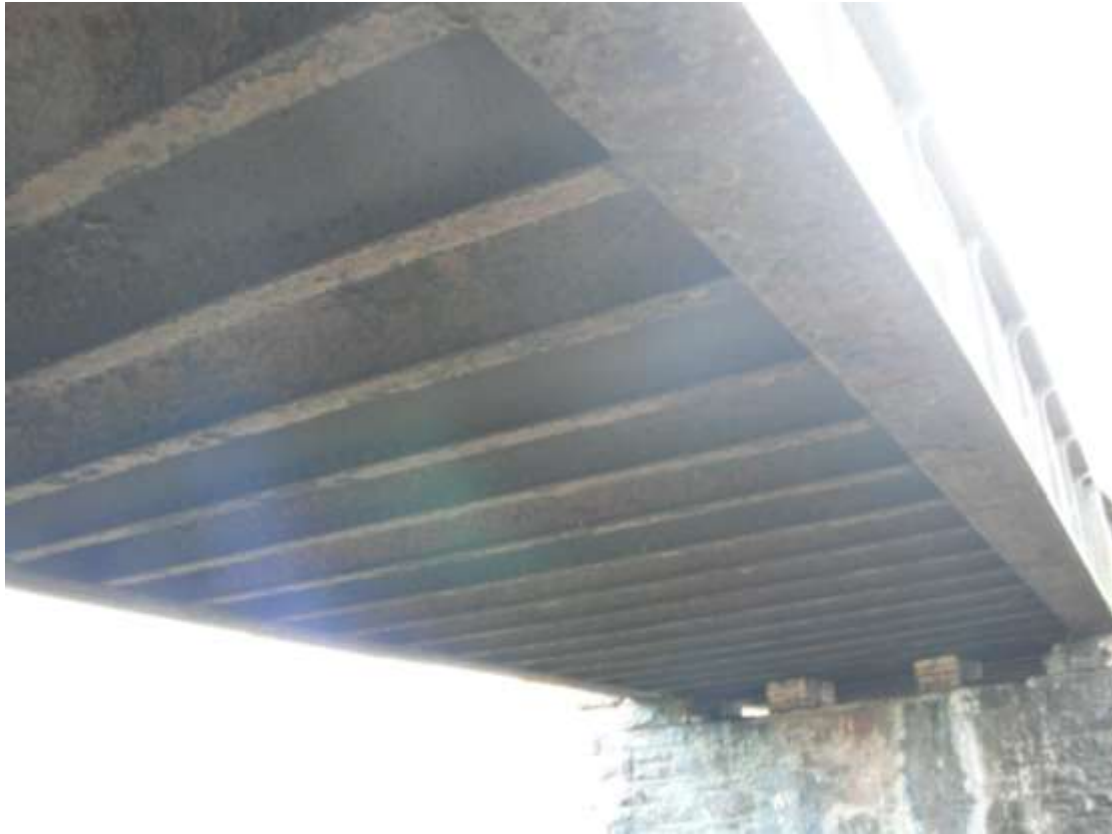
Figure 4 : Deck soffit showing minor corrosion to transverse beams.

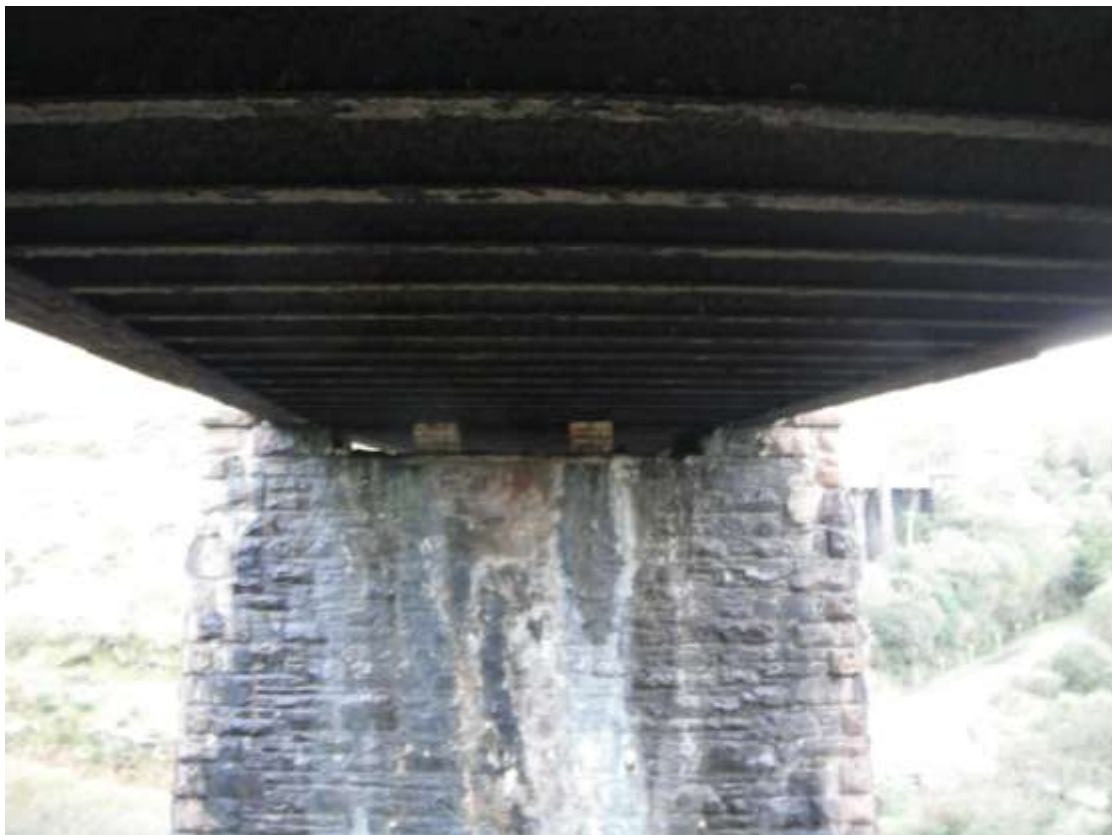
Figure 5 : Piers showing signs staining due to water percolating through expansion joints.

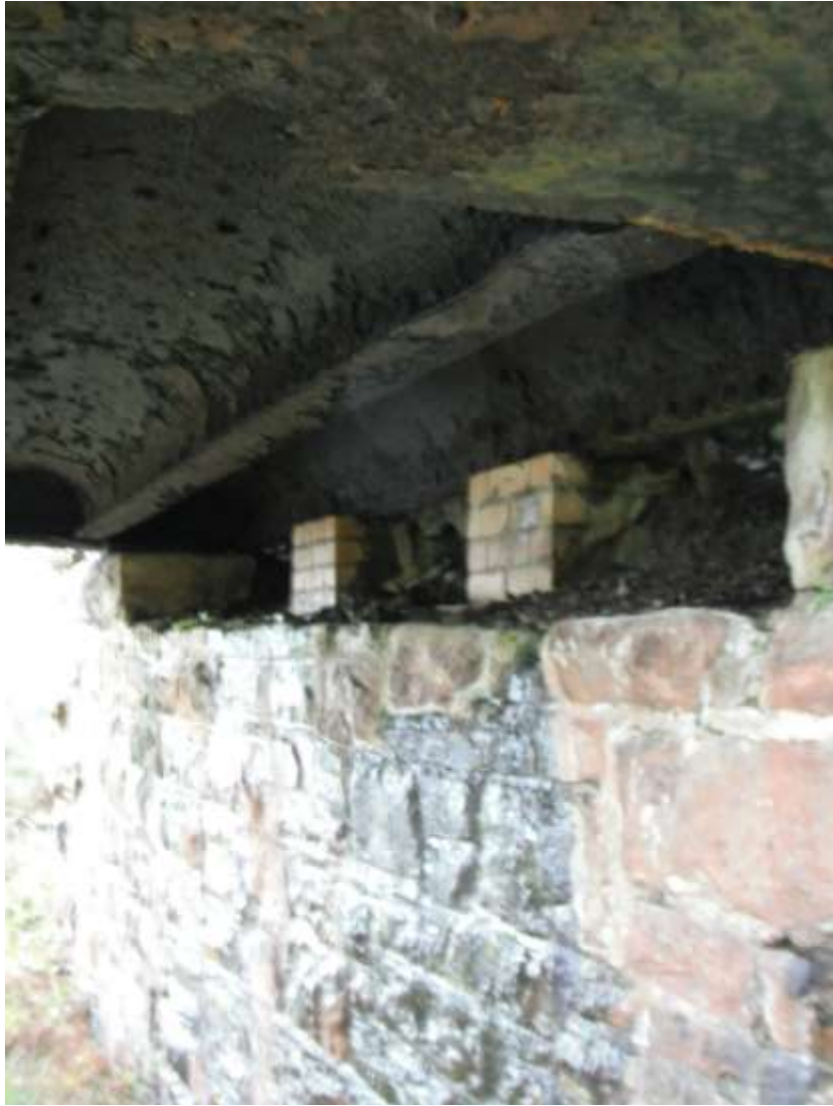
Figure 6 : Abutment - note the lack of bearings.

5	Embankment/ Slopes	-	-	-	-	-	-	-	-	-
6	Wing Walls/ Retaining Walls	-	-	-	-	-	-	-	-	-
7	Abutments	1	N	N	Abutments are in good condition nd no remedial work is required.	F6	-	-	-	-

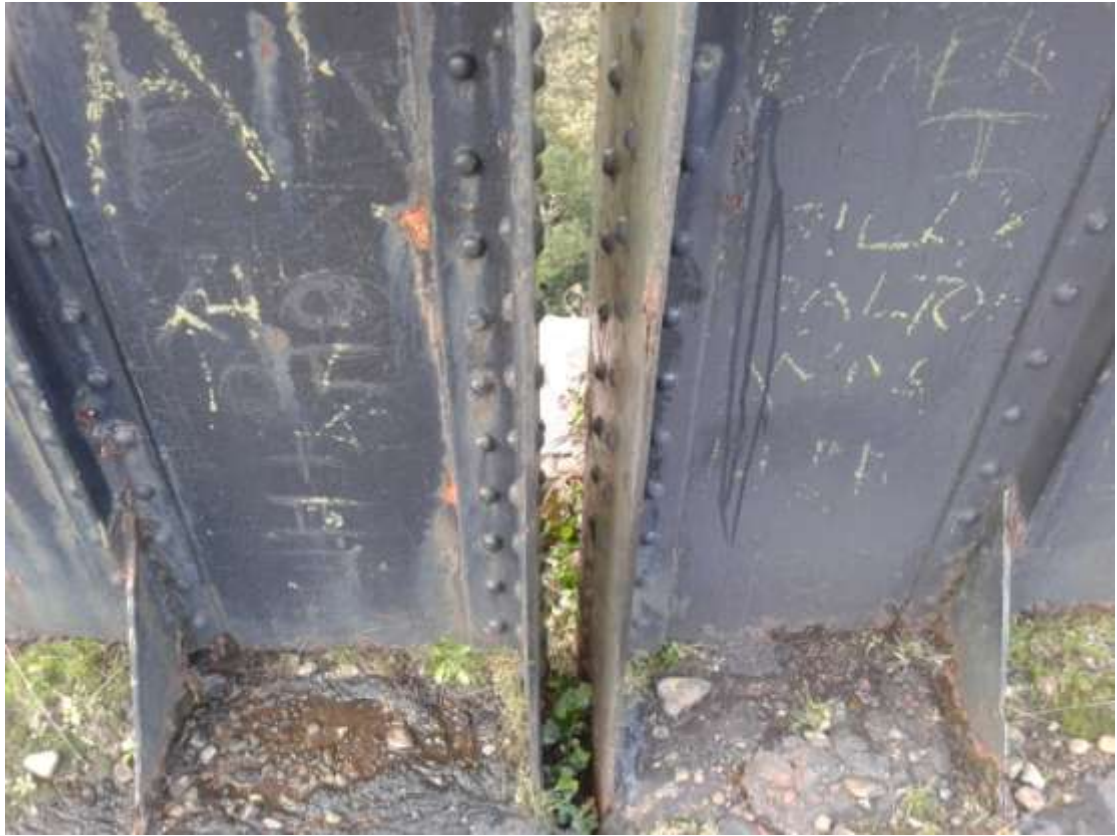
Figure 7 : View of expansion joint.
